Cutting Performance of Various Single Use Diamond Burs

Objective: To compare the bur cutting rate and visually compare SEM photos of the bur and bur cut surface of various single-use diamond burs when challenged to cut a 2-3 mm deep groove in a 5.6 mm thickness piece of plate glass.

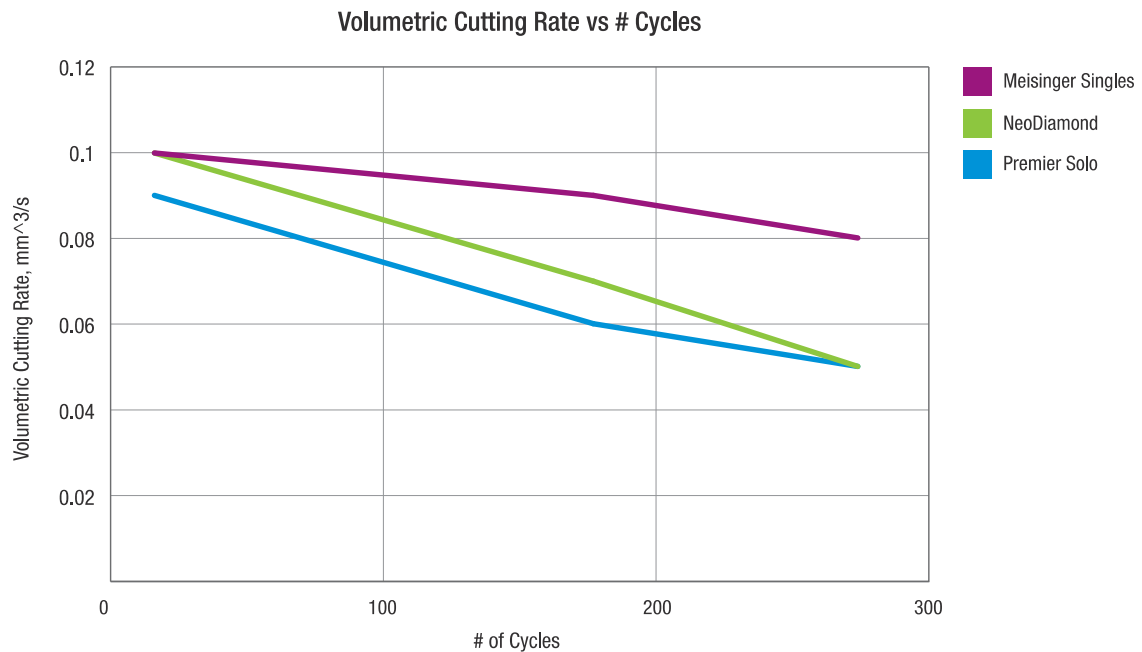
The graph below shows the volume of material removed per second for each bur product when each was driven by a Kavo air driven handpiece with an unloaded rotational speed of 250,000 RPM. The bur was cyclically loaded to 2.0 N and unloaded to 0.0 N to simulate clinical use. The period of each cycle was approximately 3 seconds which was just enough time to allow the handpiece to return to its maximum rotational speed before the next cycle would begin.

The volumetric cutting rate of the **Meisinger Singles** bur was the same as the **NeoDiamond** bur and 11% greater than the **Premier Solo** bur when measured during the first 15 cycles of use. At 275 cycles, the cutting rate of the **Meisinger Singles** bur was 60% greater than that of the **NeoDiamond** and **Premier Solo** burs and 20% less than when it was unused. The cumulative volume cut by the **Meisinger Singles** bur was 16% greater than that cut by the **NeoDiamond** bur and 36% greater than that cut by the **Premier Solo** bur at the completion of 275 cycles. The SEM analysis of the burs corroborated that the condition of the diamonds appears less worn on the **Meisinger Singles** product than for the other two products for 300 pulse cycles.

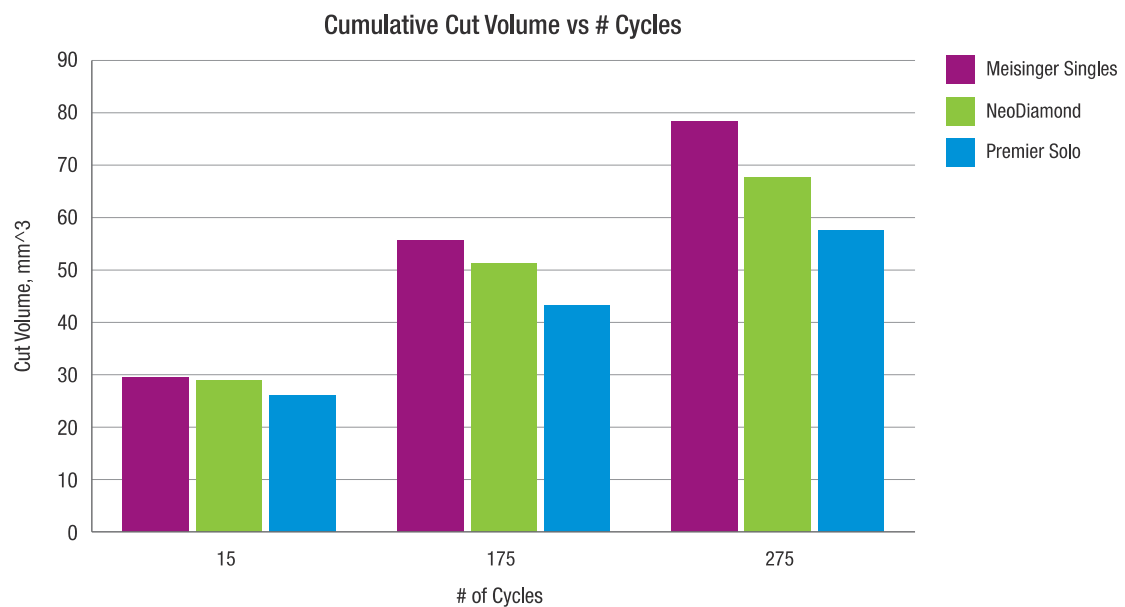
The bar chart below shows the cumulative volume of glass cut for 15, 175 and 275 cutting pulse cycles
